Properties and Performance of Hard Coatings on Tool Steels under Cyclic Indentation

In this paper cracking resistance and fatigue properties of five hard coatings - TiN, TiCN, TiAlN, AlTiN and nanocomposite nACo® (nc - AlTiN/a - Si₃N₄) on tool steels - Weartec™ and Vanadis 6 are evaluated by means of the cyclic Vickers indentation method. The analytical part covers an evaluation of damage evolution of the coated system versus the number of cycles. The effect of mechanical response - Young's module/Hardness ratio (E/H ratio) on the crack propagation is described in the form of a diagram with various curves, each one associated with a certain number of indentation cycles. The comparative adhesion testing was conducted with the use of the Rockwell C technique. It was found that the type of cracks formed in the coated systems under cyclic loading is dependant on the E/H ratio values. The data obtained enable the cracking and fatigue resistance of the coated system to be compared and an optimal coating for metal forming tools applications to be selected.

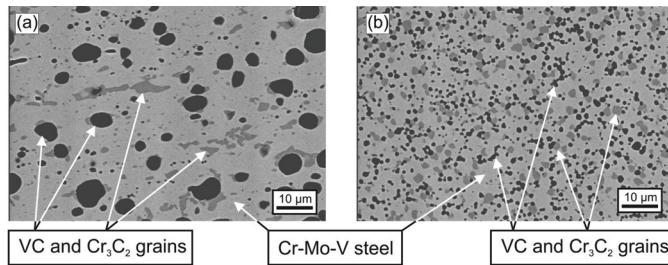
Fig. 1: SEM micrographs of steels microstructures: (a) WeartecTM (SF) and (b) Vanadis 6 (PM).

According to the manufacturer, high carbide content, size and distribution of carbides of the studied tool steels gives them an excellent friction wear (WeartecTM) and chipping/cracking resistance (Vanadis 6). Powder steels, such as Vanadis 6 (Fig. 1 (b)), have smaller carbide size than spray formed steels. Smaller grain size and carbides give a more uniform structure resulting in more homogeneous PM steel and better fracture and fatigue properties.

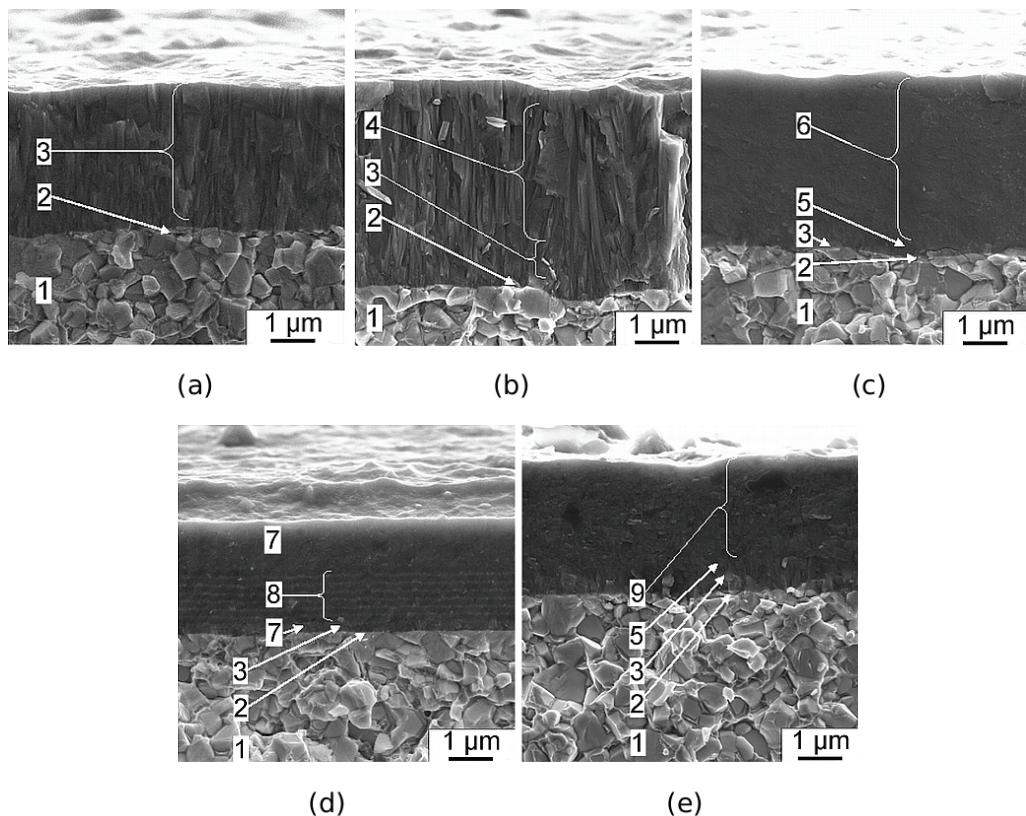
Fig. 2: SEM images of fractured surface of hard PVD coatings: (a) TiN; (b) TiCN; (c) nACo; (d) TiAlN; (e) AlTiN. 1 - substrate; 2 - Ti adhesion layer; 3 - TiN layer; 4 - TiCN gradient coating; 5 - TiAlN gradient layer + AlTiN gradient layer; 6 - nc - AlTiN/a - Si_3N_4 gradient coating; 7 - TiAlN layer; 8 - TiAlN/AlN multilayer coating; 9 - AlTiN gradient coating.

Cross-sections of PVD coated specimens observed on the scanning electron microscope (SEM) are presented in Fig. 2.

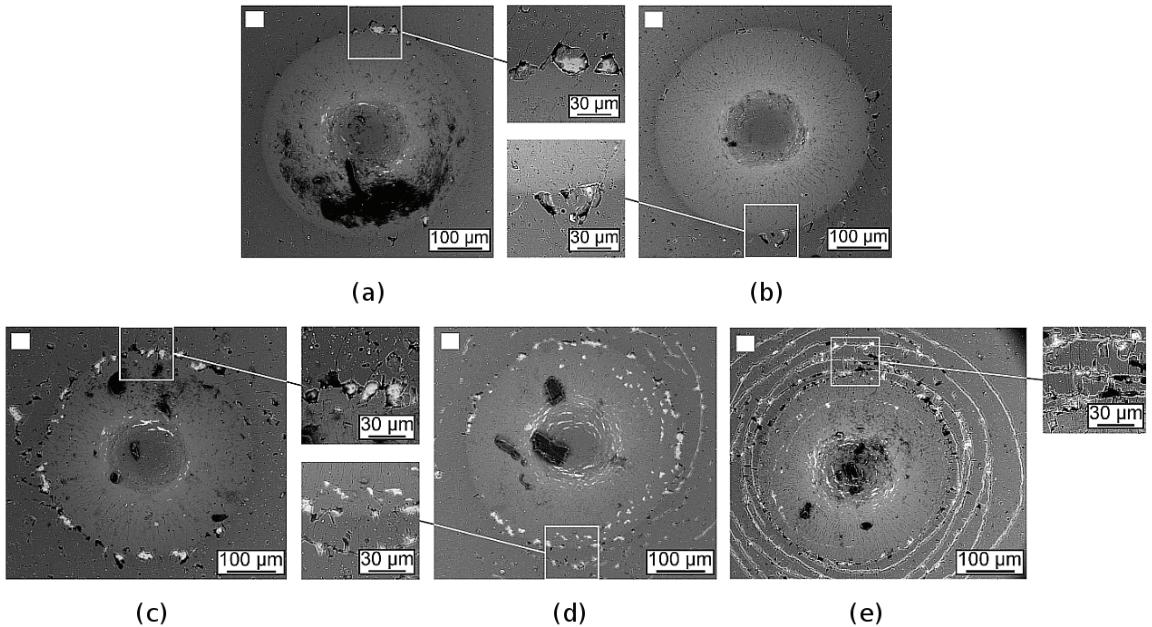
Fig. 3: SEM micrographs of the adhesion test of coatings: (a) TiN; (b) TiCN; (c) TiAlN; (d) AlTiN and (e) nACo®.

The results of the indentation test are presented by micrographs in Fig. 3. The micrographs of higher magnification are placed aside the main figures to indicate and specify coating cracking. The type and the volume of a failure zone indicate to film adhesion and its brittleness which correspond to the microstructure and the mechanical properties of the coatings. Coatings of higher hardness and lower

Young's modulus (higher E/H ratio) withstand the load without nucleation of long radial and conical cracks (TiN and TiCN). However, considerable amount of long radial cracks of 10 ... 50 μm were generated, causing the exfoliation of coating layers that is a typical behaviour of TiN and TiCN coatings under loading [1]. The longest radial cracks are indicated in the TiN coating and numerous en-folds and larger in size exfoliations of the coating layer are observed (Fig. 3 (a)). It is obvious that radial cracks predispose that kind of coating failure. The same features are seen in the case of TiAlN coating with only difference - the conical cracks are also present (Fig. 3 (c)). It seems that short radial cracks accelerate chipping on the bordering area of coating-indenter contact. Emerged chips tend to make connections with the closest on the sides forming the ring or conical crack. The structural defects presented on the surface, such as pores and non-metallic inclusions, simplify this action.

Finally, the most drastically fractured case - nACo® coating (Fig. 3 (e)). The worst performance of this coating was indicated by the numerous short radial and closed conical cracks. First, the very brittle structure collapses around the indenter and then starts to take up (absorb) fracture energy by the formation of radial cracks. Eventually those are blunted by the perpendicularly formed conical

impression, in addition to radial cracks and delamination of the coating at indent impression corners validating the results of the adhesion test (Fig. 3 (e)).

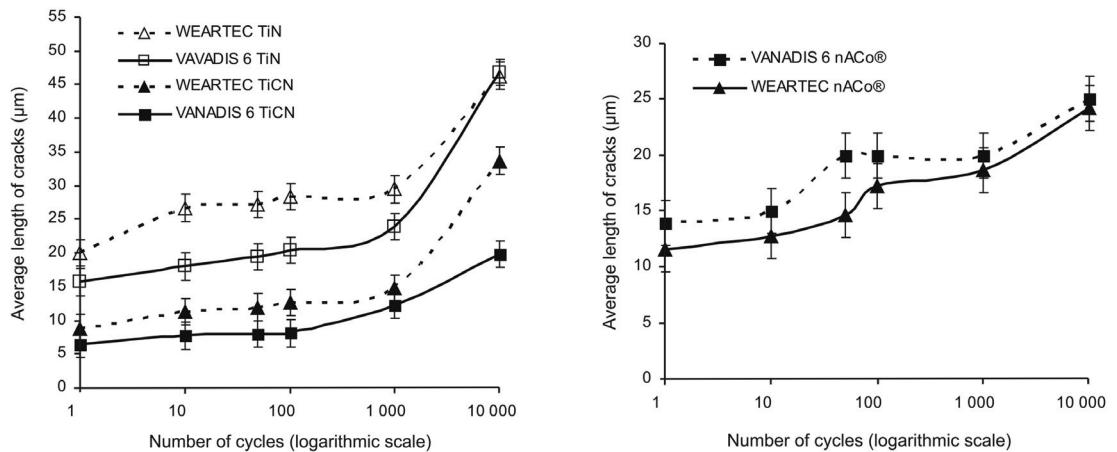
Fig. 4: An average length of radial cracks measured from the indent impression corners depending on the number of indentation cycles, substrate material and coating combinations: (a) TiN and TiCN; (b) nACo on Weartec™ and Vanadis 6 substrates.

To estimate the cracking resistance of the coated system, a quantitative analysis of the samples was performed. The lengths of radial cracks from the impression corner were measured and presented on graphs (Fig. 4, 5) versus the number of indentation cycles. The error bars show the standard deviation of $2.3 \mu\text{m}$.

Similarly to the single loading of the adhesion test, TiCN coating on both substrates had the best cracking resistance at all cycle values (Fig. 4). TiCN on Vanadis 6 showed radial cracks with a length of $20 \mu\text{m}$ and crack evaluation criteria II (Fig. 4 (a), Fig. 6 (a)). On the contrary, nACo® on both substrates had the lowest cracking resistance (Fig. 7 (c)). The cracking of this coating differed from others with the formation of cone cracks around the

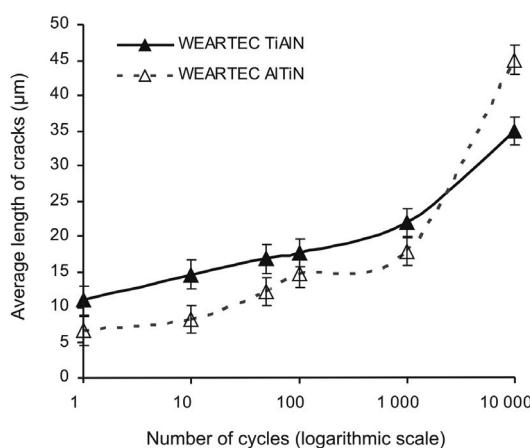
Fig. 5: *An average length of radial cracks measured from the indent impression corner depending on the number of indentation cycles of TiAlN and AlTiN on WeartecTM substrate.*

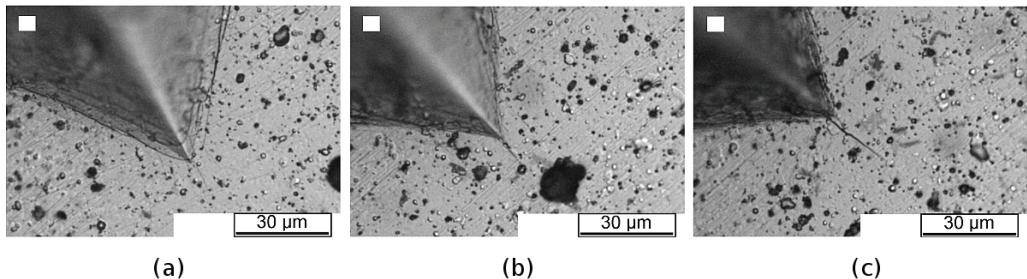
Fig. 6: Impression corner of TiCN on Vanadis 6 substrate with the appearance of 0 criteria after: (a) 1 cycle. I criteria after: (b) 1000 cycles. II criteria after: (c) 10 000 cycles.

dial cracks were observed in the corners of the impression (Fig. 6 (a)).

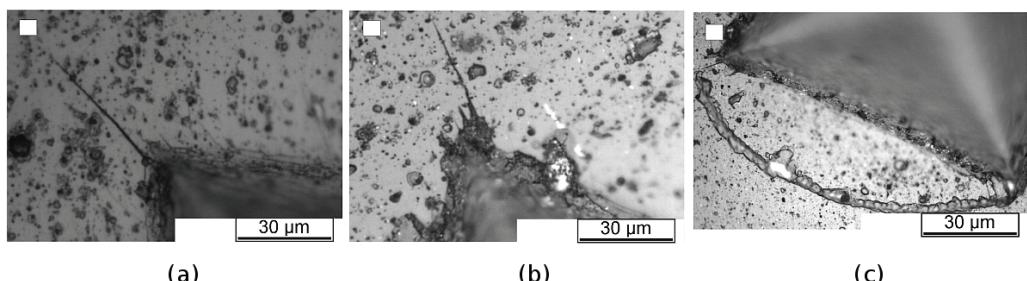
Fig. 7: Impression corner of coatings on WeartecTM after 10 000 cycles with the appearance of IV criteria: (a) TiN; VI criteria: (b) AlTiN; V criteria: (c) nACo®.

delamination of the coating around the corners of the impression. TiAlN was less damaged and it had higher E/H ratio than AlTiN (Fig. 7 (b)). In addition, cyclic indentation test revealed that multilayer coatings are preferable over monolayer TiN coating with one of the lowest cracking resistance and the formation of strong radial cracks with the length of about 47 μm despite high E/H ratio of TiN (Fig. 7 (a)).

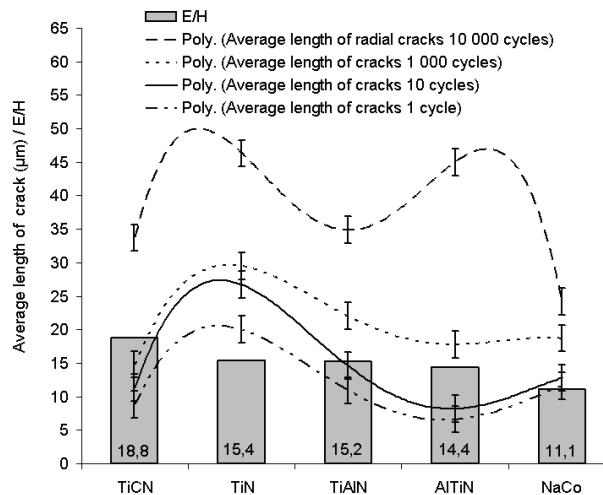
Fig. 8: The effect of the E/H ratio on the radial crack propagation (coatings on Weartec™).

of E/H (nACo[®]) showed cone cracking and delamination. The dependence between radial cracking sequence and E/H ratio values was described in the form of a diagram (Fig. 8). Each curve

on the diagram is associated with a certain number of indentation cycles. According to the diagram curves, TiAlN has medium and AlTiN strong radial cracks after 10 000 cycles. Both coatings showed

Despite the lowest length of the radial cracks, as shown in the diagram (Fig. 8), nACo® coating on WeartecTM had the worst performance. The appearance of the shortest radial cracks can be explained by the formation of additional cone cracks after 1 000 and 10 000 indentation cycles what hamper the propagation of the radial cracks.
